# LeRoy Airport (5G0)

## Environmental Assessment - **DRAFT**

Prepared For:  
**LeRoy Aviation Services, Inc.**  
January 2021

Prepared By:  
**Passero Associates**

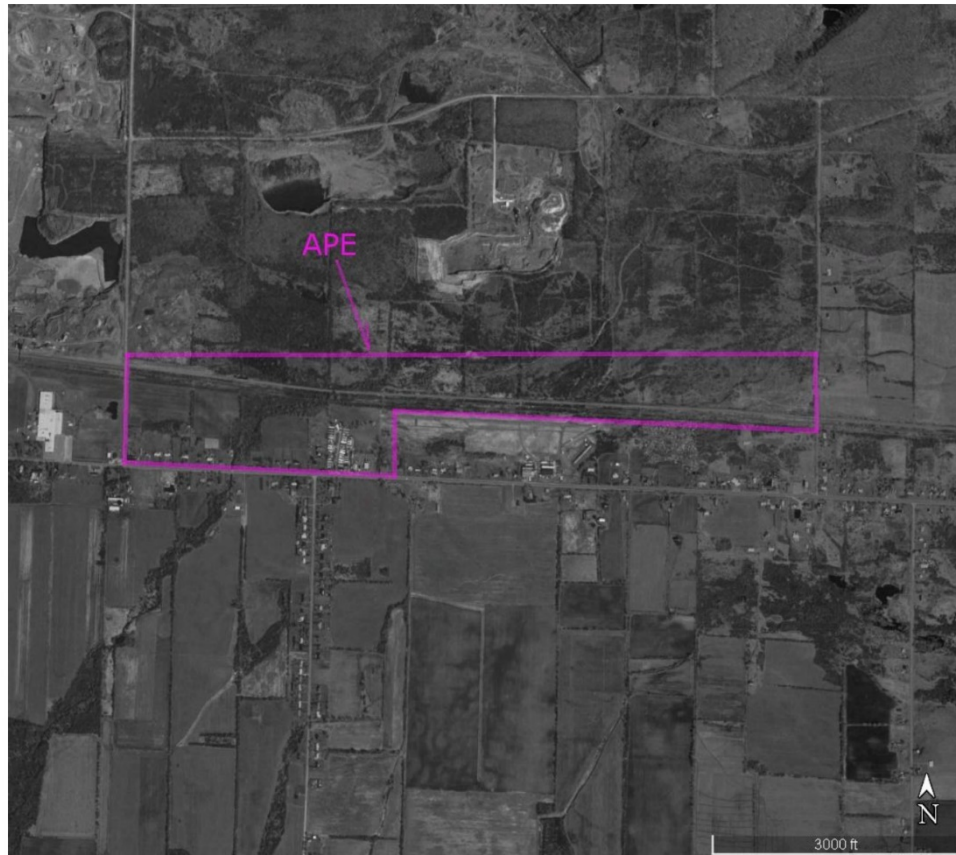
Figure 8: APE on Google Earth: Imagery date April 1995

The 1995 aerial (Figure 8) shows that quarrying operations have moved south of Gulf Road and may have already impacted the APE in several places. This appears true along the northern border, especially in the central section immediately below the easily-seen quarrying operations. Bare earth, numerous trails/access roads, and irregular vegetation patterns suggest soil disturbance may have occurred years prior to this photograph, possibly involving the removal of topsoil deposits prior to expected quarrying operations in those areas. The northward railroad connector is no longer seen and it appears that the two (2) southernmost railroad tracks have been abandoned and allowed to revegetate. There has also been a tremendous growth in the number of structures now within the APE along the north side of East Main Road. The establishment of a mobile home park and about a dozen frame structures has dramatically increased the human footprint and impacts along this section of the APE as lands were leveled to provide building lots. The presence of a now-operational Le Roy Airport can be seen just east and south of the APE as this time. Lands behind the structures on East Main Road and the railroad tracks at the western

end of the APE are seen as active farm fields in 1995 and are considered to be the only lands in the APE that have not been significantly impacted by soil-disturbing activities by this time. Figure 9 is an aerial from 2009 that shows the expanded quarry now directly abuts the APE along the northern border, with at least part of the impacted lands extending into the APE. The single operational railroad line is well-defined, as are the two (2) overgrown abandoned railroad beds. The lands fronting East Main Road within the APE are almost totally developed by this time, but the farm lands behind these structures still exist. Conditions within and adjacent to the APE continue to remain relatively stable from 2009 into the present day as shown by Figures 2 and 10 except the East Main Street Cemetery is now noted a Buell Cemetery on Figure 2. Records note this cemetery as containing burials from the early 1800s up to the early 20<sup>th</sup> century and while the grounds are well-maintained, precise boundaries were not seen other than treed hedgerows between adjacent properties at 8079-83 East Main Road and 8103 East Main Road (Figure 11).

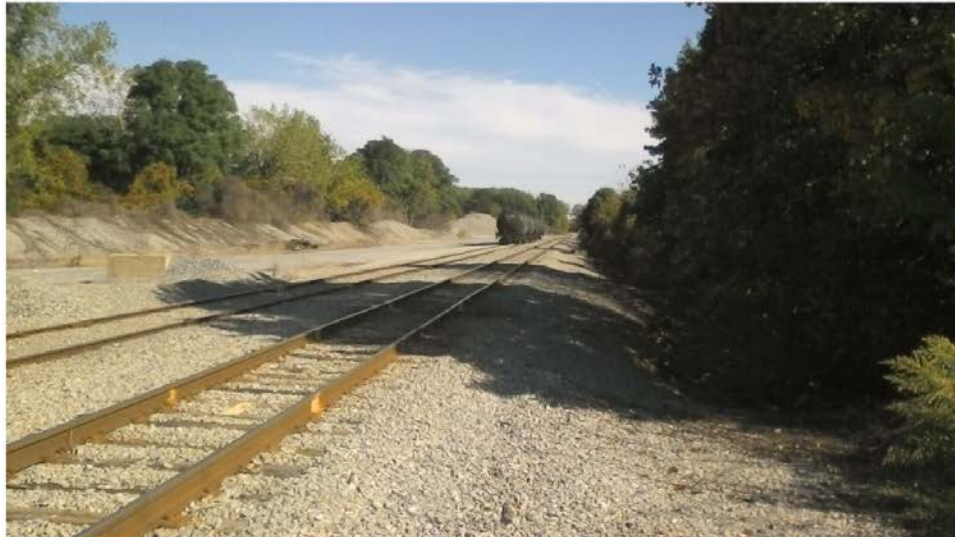
Photograph 3: View along northernmost railroad grade in APE from Circular Hill Road, note total disturbance of soils in expand footprint and large spoil pile adjacent to quarry to north (left), facing east

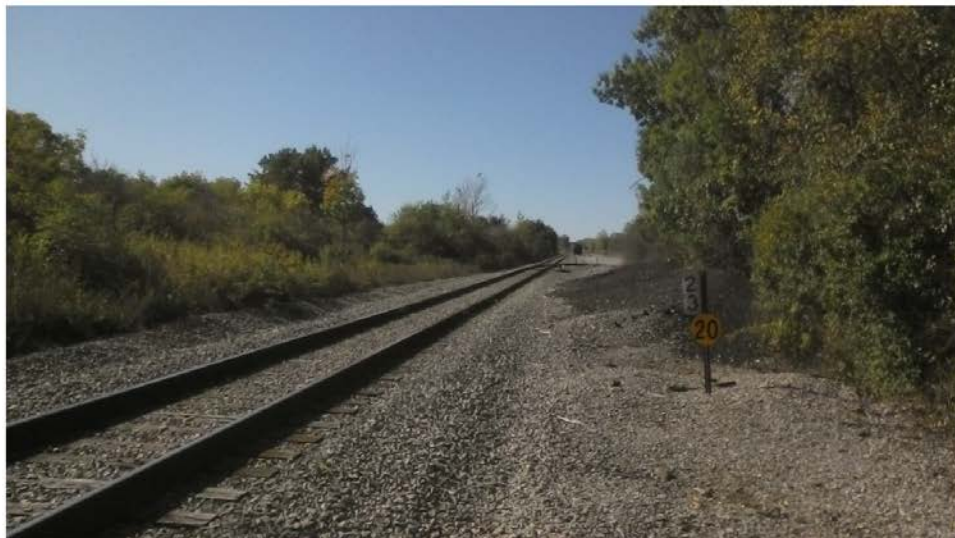
Photograph 4: View along operational railroad track from east of expanded track area near Circular Hill Road, note total disturbance of soils and large spoil pile on north (right), facing west

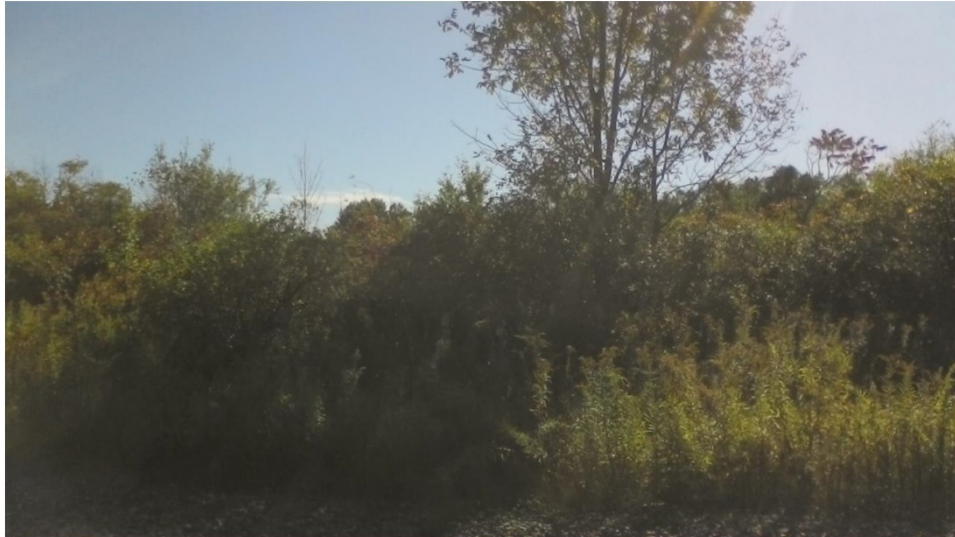
Photograph 5: View towards abandoned railroad grades showing disturbance associated with ditching and the creation of the railroad bed, facing southeast

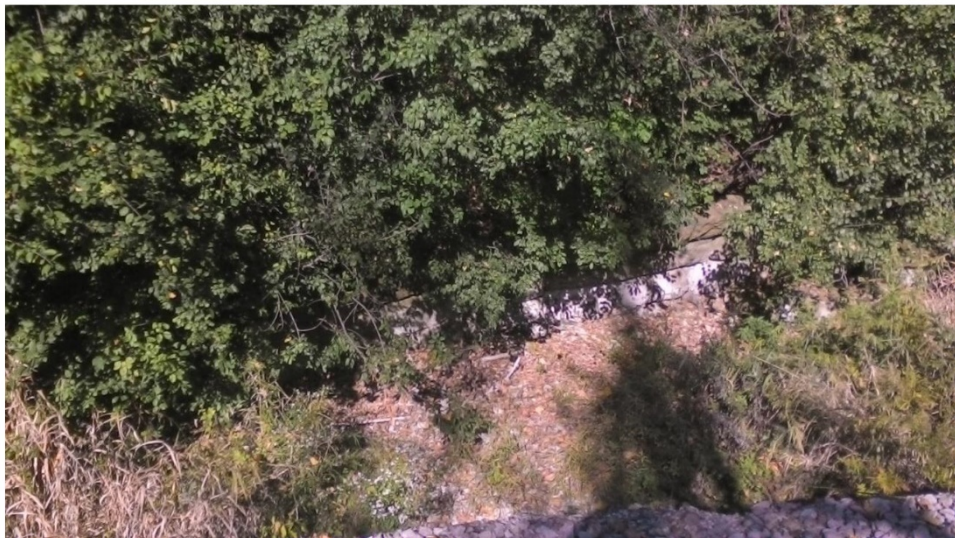
Photograph 6: View of channelized ditch (Mud Creek?) between the existing railroad and quarry, noted steep bank on quarry side comprised of spoil piles of displaced soil and stones, facing north

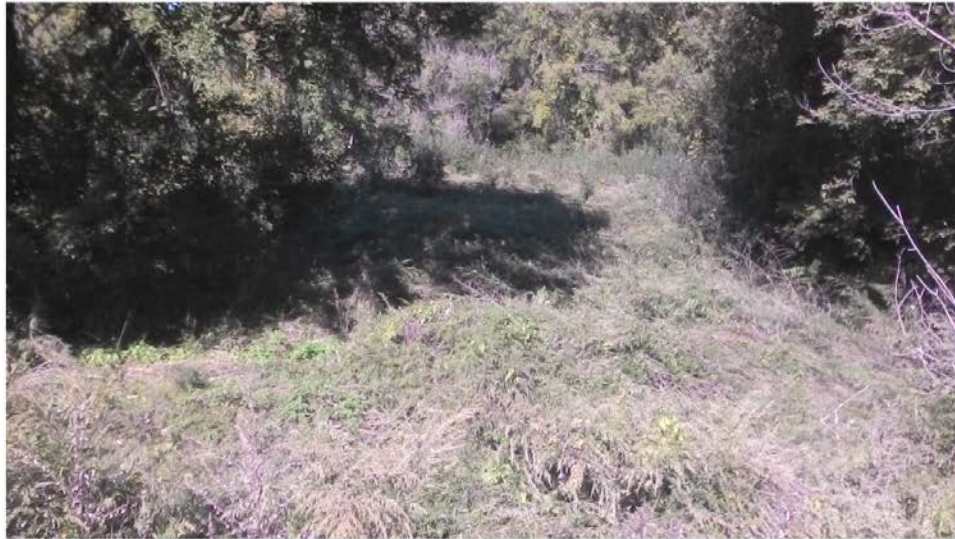
Photograph 7: View of displaced soils in quarry lands north of existing railroad tracks, facing north

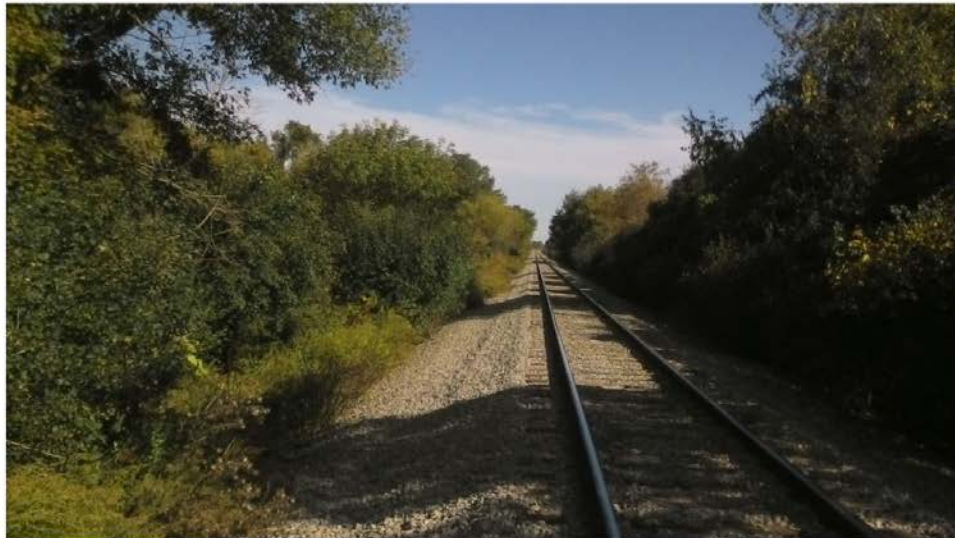
Photograph 8: General conditions along operational railroads tracks in central part of APE, note substantial ditching and heavily-vegetated berms on both sides (abandoned railroads grades to south/right and quarry to north/left), facing east

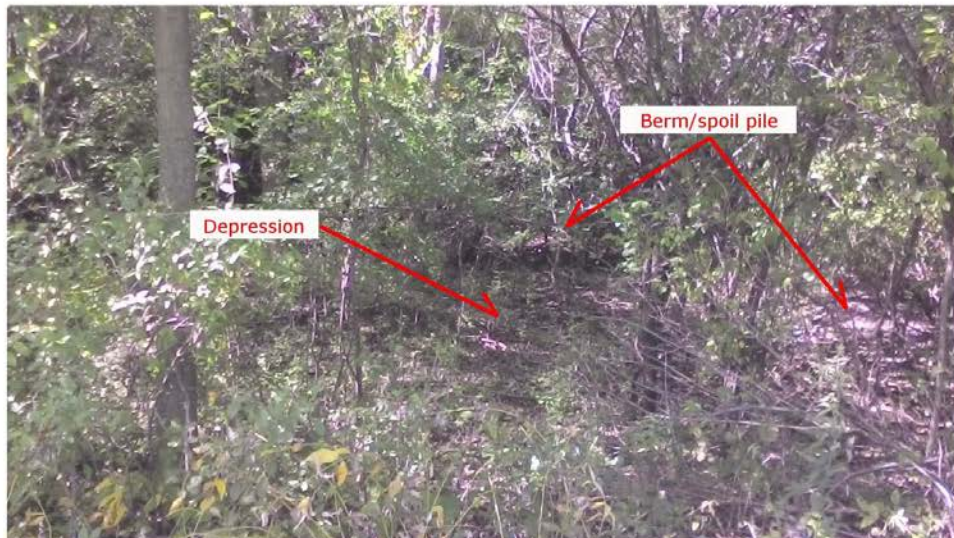
Photograph 9: Typical soil berms/spoil piles and adjacent depressions indicating disturbance of lands north of the railroad line in the former kiln quarry west of Church Road, facing west

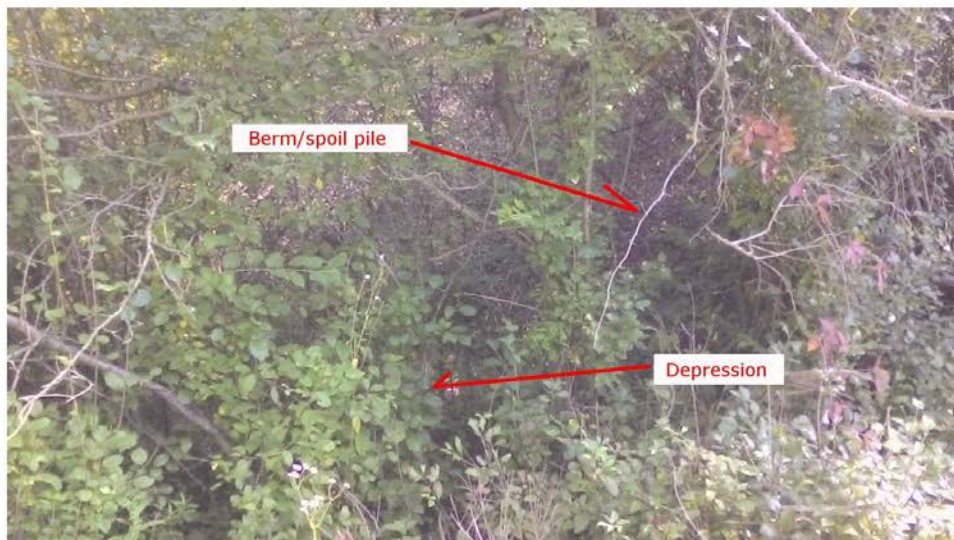
Photograph 10: Typical soil berms/spoil piles and adjacent depressions indicating disturbance of lands north of the railroad line in the former kiln quarry west of Church Road, facing east

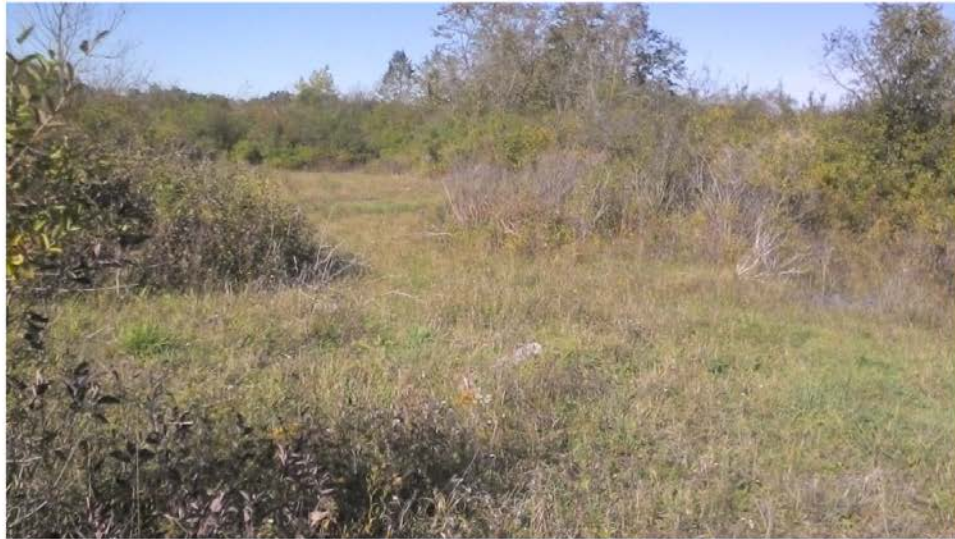
Photograph 11: Typical disturbed conditions in former kiln area west of Church Road showing evidence of grading (note spoil piles on south/left adjacent to operational railroad tracks), facing northwest

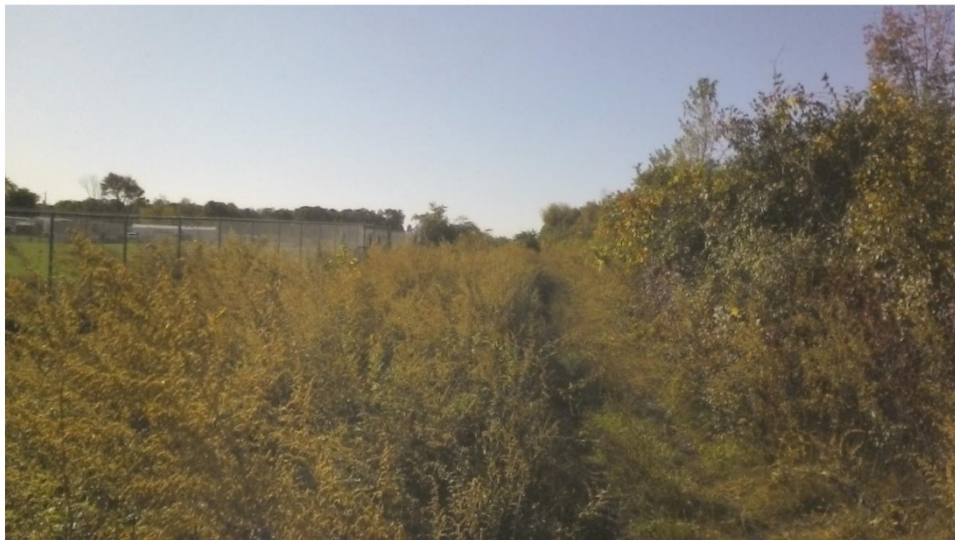
Photograph 14: View along disturbed section south of abandoned railroad grades, facing west

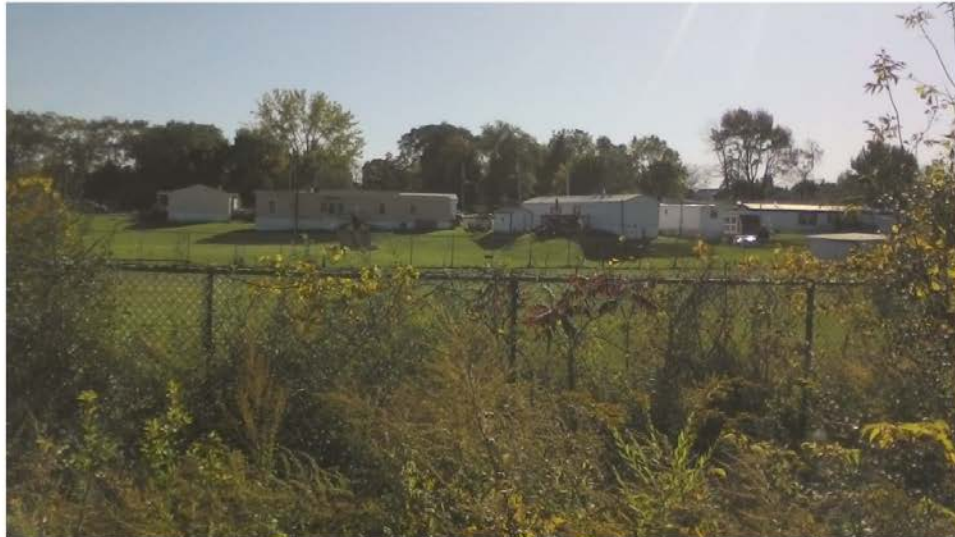
Photograph 15: View of mobile home park that fronts East Main Road showing typical landscape modifications (filling and grading) for development, facing south

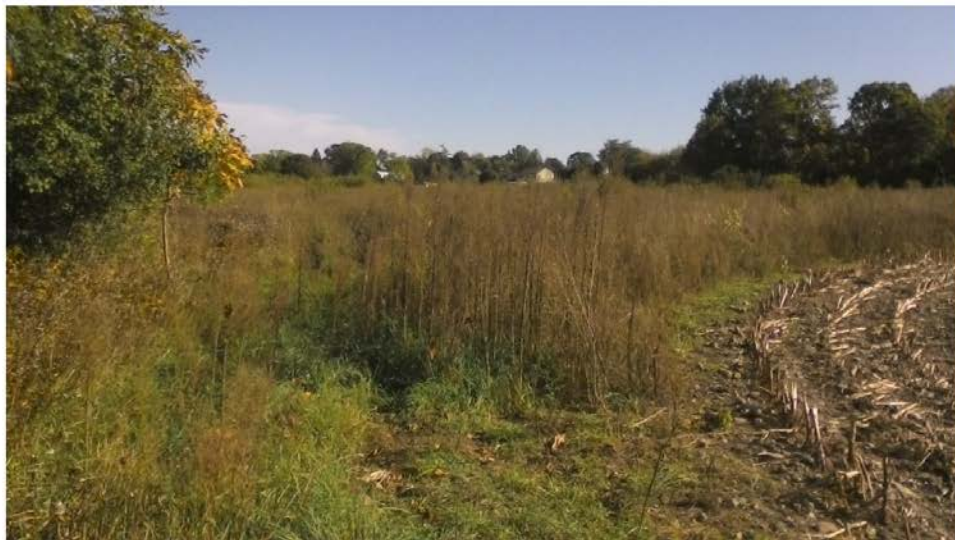
Photograph 16: Potentially undisturbed section of APE in former agricultural fields east of Circular Hill Road and between the abandoned railroad grades and structures fronting East Main Road, facing east-southeast

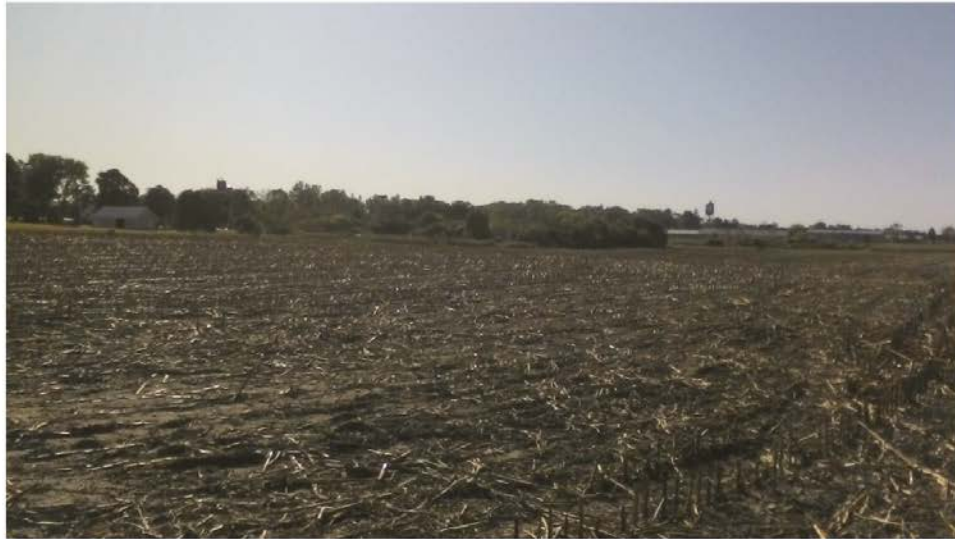
Photograph 17: Potentially undisturbed section of APE in active agricultural fields east of Circular Hill Road and between the abandoned railroad grades and structures fronting East Main Road, facing southwest

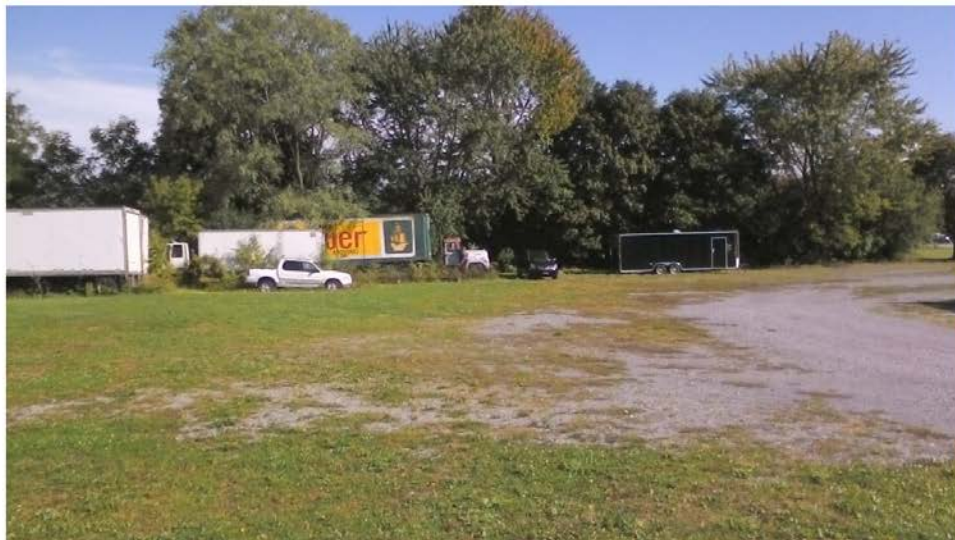
Photograph 18: Typical modification of lots adjacent to East Main Road for development, facing east

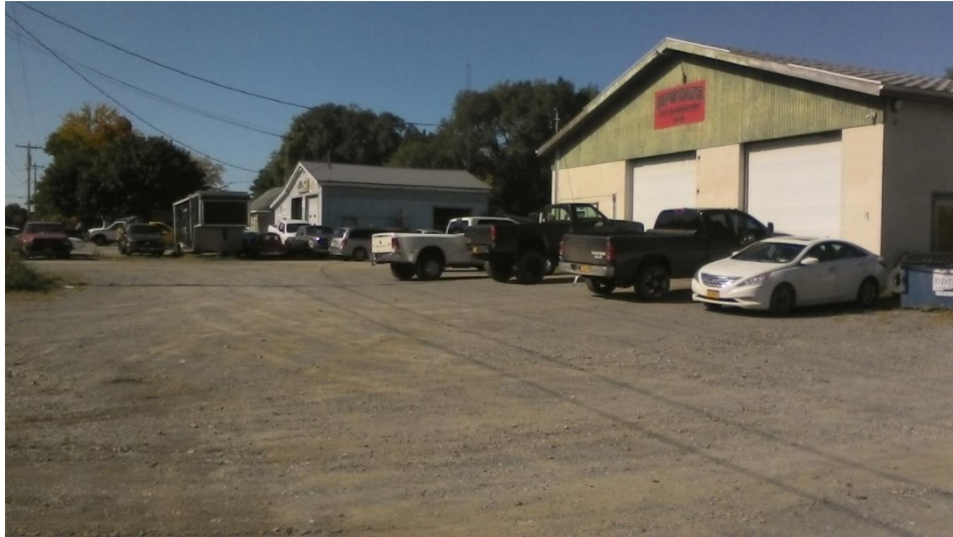
Photograph 19: Typical modification of lots adjacent to East Main Road for development, facing west-northwest

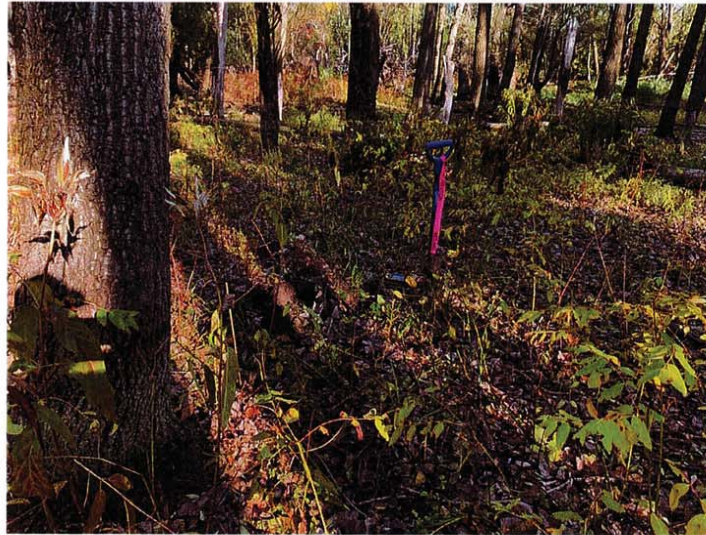
Photo 1. Photo of Sample Point 1 within Wetland A

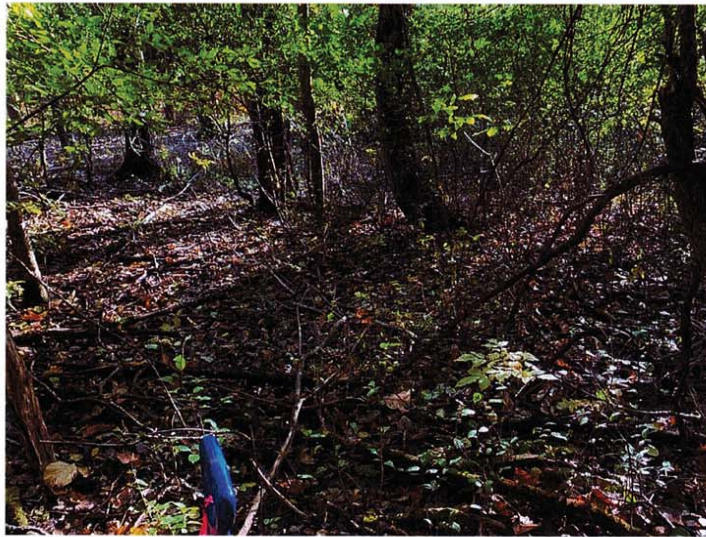
Photo 2. Photo of Sample Point 2 north of Wetland A

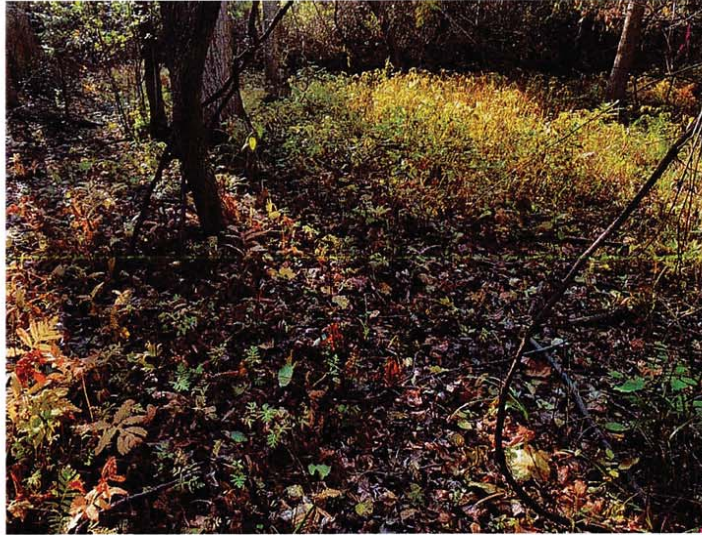
Photo 3. Photo of Sample Point 3 within Wetland A

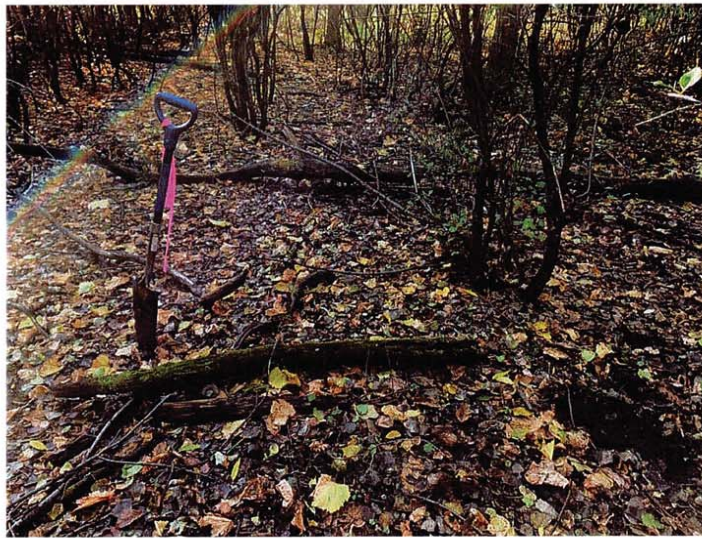
Photo 4. Photo of Sample Point 4 east of Wetland A

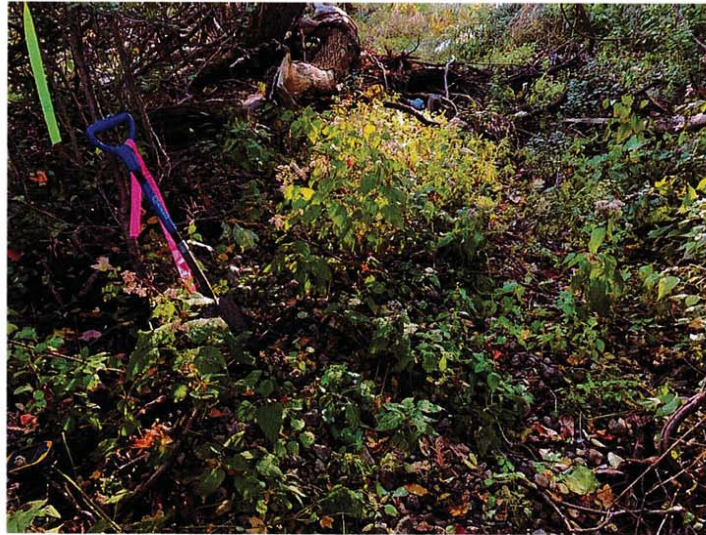
Photo 5. Photo of Sample Point 5 adjacent to west side of Mud Creek

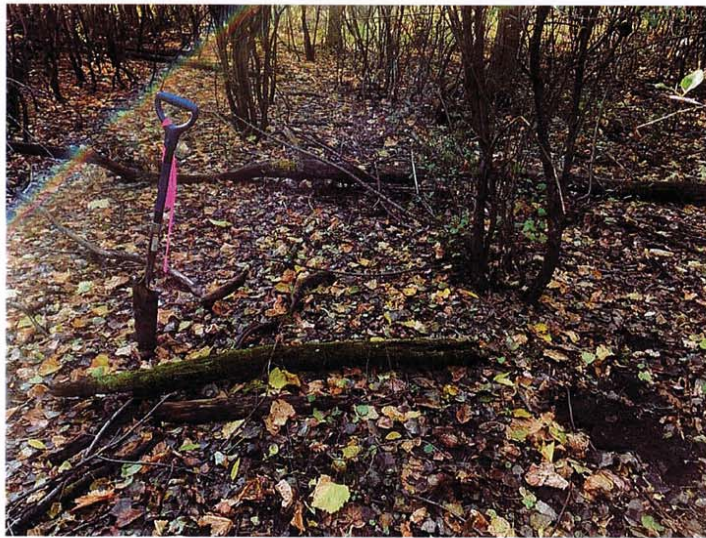
Photo 6. Photo of Sample Point 6 adjacent to east side of Mud Creek

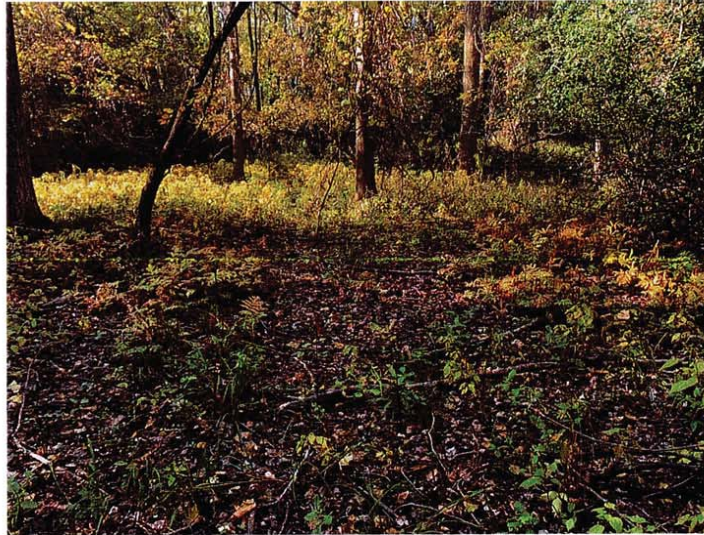
Photo 7. Photo of eastern portion of forested Wetland A within north wetland screening area

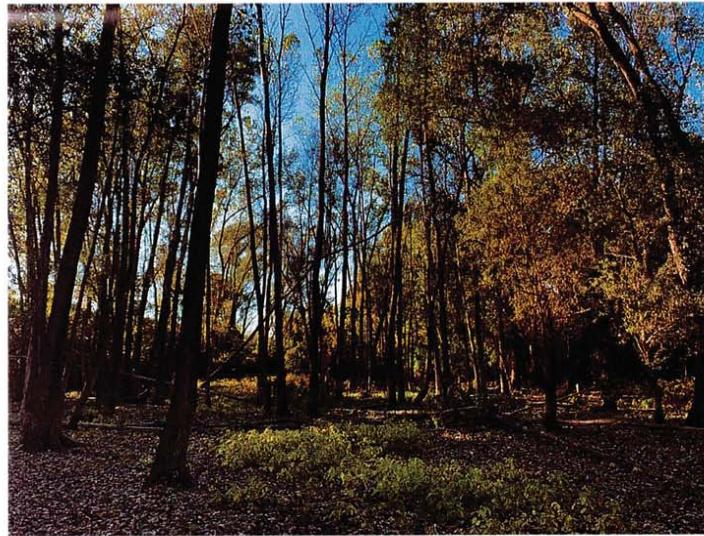
Photo 8. Photo of western portion of forested Wetland A within north wetland screening area
